**Capital Improvements Plan -
Recommendations for Camelback
Mountain Resort**

100% Deliverable

Lafayette College EGRS 451 Capstone Group

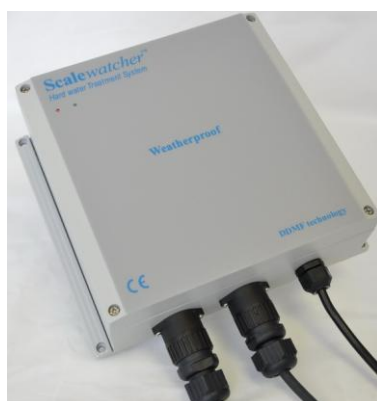
The most economical and effective solution to the existing hard water problems at Camelback is an electronic water conditioner (see Figure 2.1). A water conditioner uses electronic signal wires wrapped around a copper, PVC or PEX pipe to send electronic frequencies (not actual electricity) through the pipe resulting in molecular agitation (Easy Water). It is relatively compact, inexpensive, requires low maintenance and is considered sustainable (Easy Water). The water conditioner facilitates water flow by using specific frequencies that readjust the formation of the minerals such as the magnesium, and calcium in the water from elongated branches to disks (Faraday's Law), causing them to lose their electrostatic property and ability to stick to surfaces (Easy Water). The water conditioning process only addresses the water hardness. There is no effect on the taste or smell of the water, since it does not add or remove any mineral content.

Figure 2.1: Scalewatcher Commercial water conditioner (Scalewatcher)

The product that best fits Camelback's needs is the Scalewatcher Commercial (CM model line) of water conditioners (Figure 2.1). This line of models has specific models for many different pipe sizes, which makes them very easy to apply to any water system (Scalewatcher). What also makes these models easily applied is the fact that they are designed for a specific diameter of pipe rather than water pressure and flow, which can vary within such a large water pipe system as the one at Camelback. The Scalewatcher Company has proven itself on the worldwide market with a number of large and established customers, such as Guinness Brewing and Hilton Hotels, and it has an A+ rating from the Better Business Bureau (Scalewatcher). This is proof enough that these

water conditioners have been successfully implemented within commercial settings and that the customers of the Scalewatcher company have been thoroughly satisfied. The CM models use very little electricity (less than 100mA, 110 V) (Scalewatcher). They also maintain the small dimensions of 6.3"x3.9"x2.5" (Scalewatcher). They are competitively priced against other water conditioners at \$999 for the 2 inch diameter pipe model and \$1899 for the 4 inch diameter pipe model (Scalewatcher). For all of these reasons, the Scalewatcher Commercial CM line is the most appropriate solution to the problems that hard water causes at the Camelback Resort.

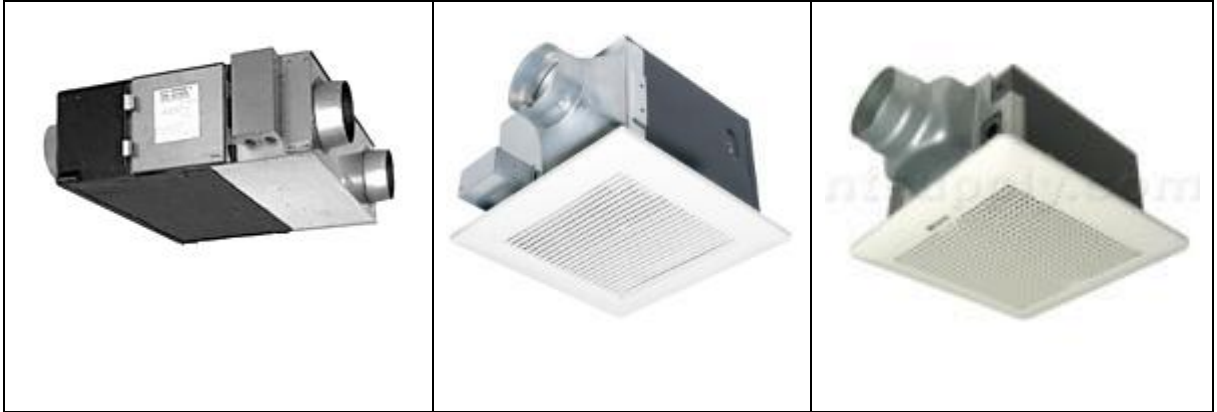
Three companies, which produce ERV systems, have been identified as currently producers of the best systems in the market—Mitsubishi Electric, Panasonic and RenewAire. Mitsubishi manufactures Lossnay ERV, which provides outdoor air solutions to improve indoor environmental quality; Panasonic manufactures WhisperGreen, a ceiling mounted continuous- and spot-ventilation fan with a SmartAction Motion Sensor and Light; RenewAire also manufactures a ceiling mounted fan. The recommended manufacture is RenewAire because they provide a range of ERV models, from a single ceiling unit to indoor and outdoor central units. See Appendix B for details.

Figure 2.3: Mitsubishi Lossnay, Panasonic Whisper Green and RenewAire Vseries (Mitsubishi Electric & Electronics, Panasonic, RenewAire)

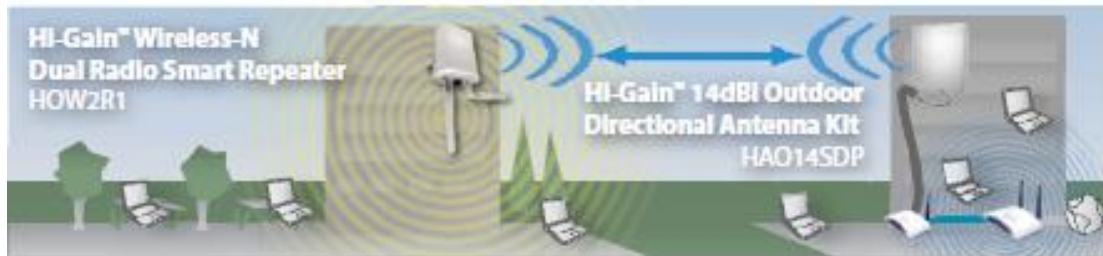
the desired location. To combat signal transmission issues stemming from the steep grade of the mountain, we have taken advantage of the long, straight clearings needed for the ski lifts as alleyways through which the signal can be transmitted up the mountain. The existence of these alleys is important because signal propagation between antennas of this size requires a clear line-of-sight.

Figure 5.1: General Scheme for Long-Distance Signal Transmission (Hawking)

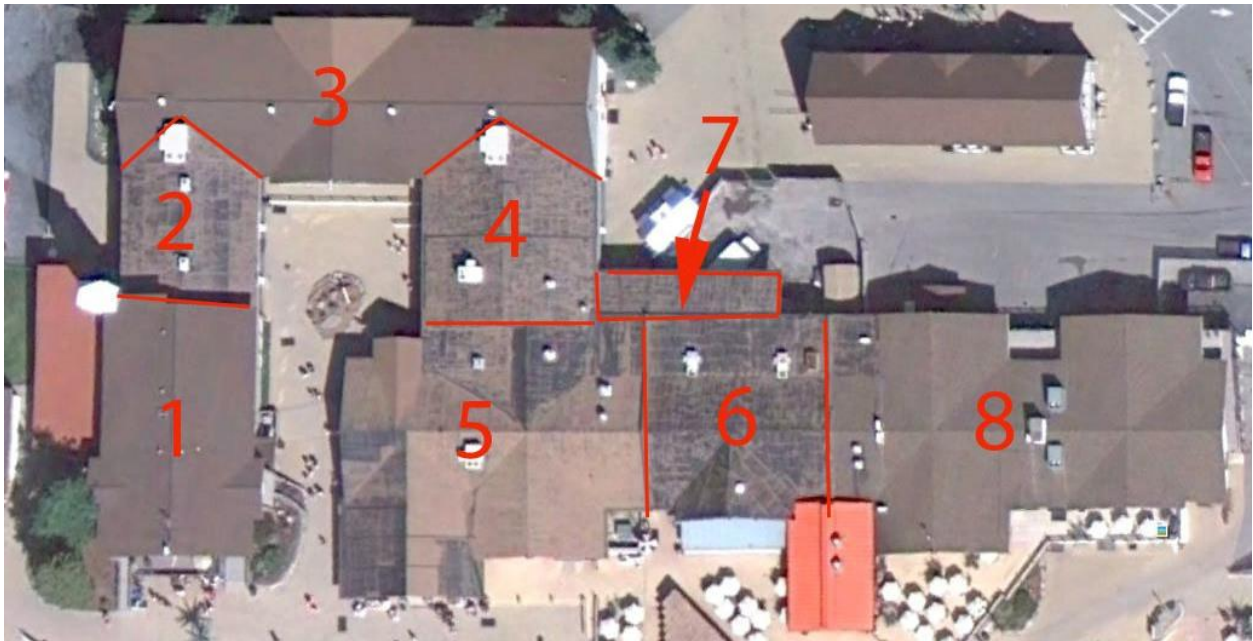
Figure A.1. Layout of the Main Lodge roof (Google Earth, 2011).

Using Google Maps, we estimated the square footage of the roof for Camelback's Main Lodge see, Appendix A Figure A.1. Overall we found that the roof is approximately 42,000 square feet. This is a rough estimate that does not fully consider the perspective of the map and the pitch of the roof.

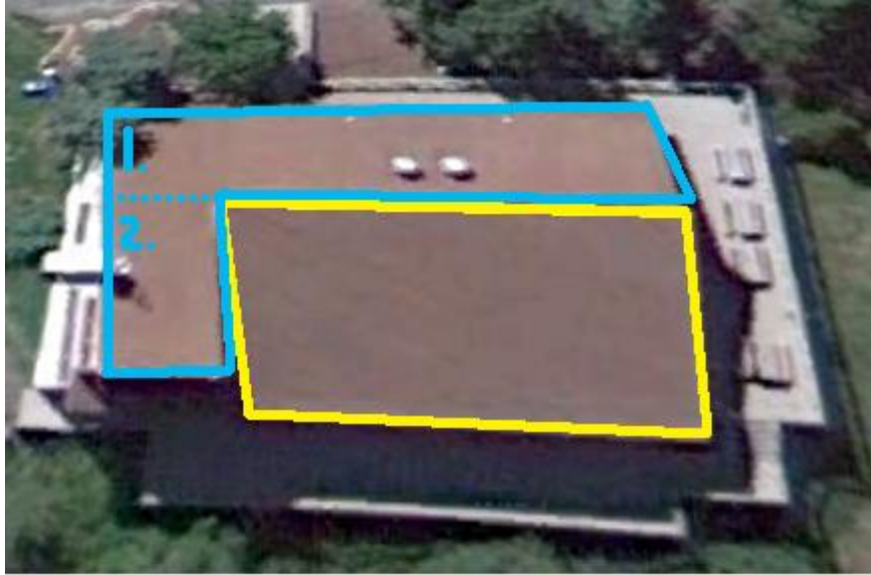
Figure D.1: Aerial view of CamelTop, showing three separate roof sections: A (yellow), B1 and B2 (blue) (Google Earth, 2011). Only south-facing sections are being considered for optimal PV placement.

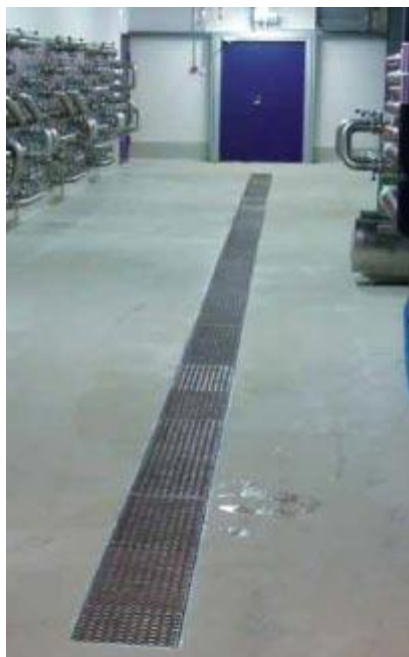
Figure D.2: Sample image of typical kitchen trench drain installed (trenchdrains.biz).

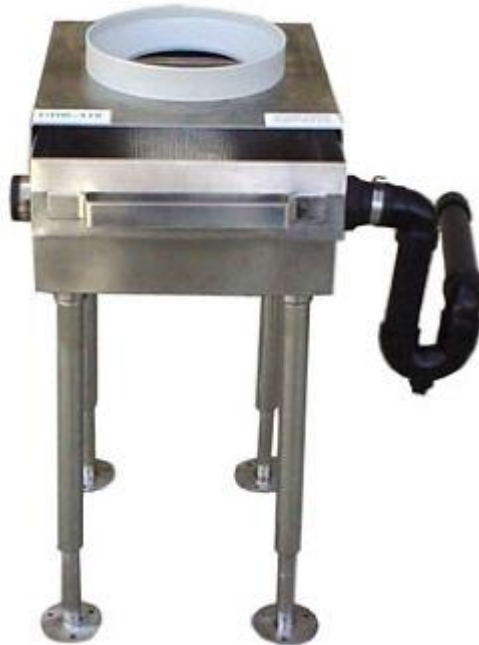
Figure D.3: Garbage disposal replacement unit; typically mounted underneath sink drains to strain out food and debris from entering plumbing (drain-nets.com)
